# Stress Concentration and Fatigue Crack Propagation at the Fir-Tree Root of Gas Turbine Disks Caused by Interconnection Tube Failure between Blades

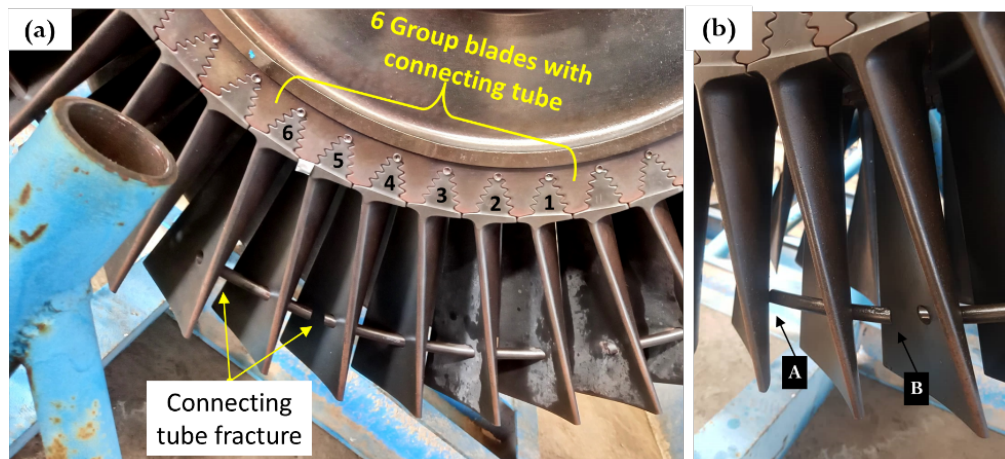
failed interconnection tube was conducted by means of systematic visual inspection and photographic documentation. The fractured interconnection tube is presented in Fig. 3. The damage was confined to the six-blade group and was specifically located at the left and right sides of the fifth blade within this group. No other visible damage was observed in the remaining blade groups at this stage of the inspection.

**Fig. 3.** Photographs showing the positions which a) interconnection tube is failed. b) Location A and Location B.

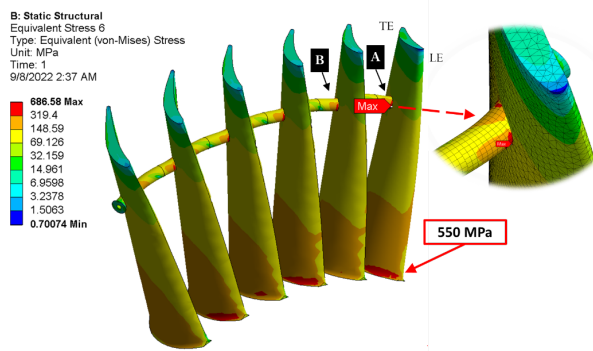
The reason for using static stress analysis was to determine how tensile stress forms on the fractured surface where crack is formed. The majority of this tensile stress is due to centrifugal load. Fig. 6 indicates equivalent von Mises stress distribution while group blades are connected to the interconnection tube. Clearly, the highest stress of 686 MPa is less than the yield strength IN718 (Table 1). Therefore, the system can sustain the forces under static conditions with no major crack.

**Fig. 6.** Distribution of von-misses stress of the group blades under static loads.

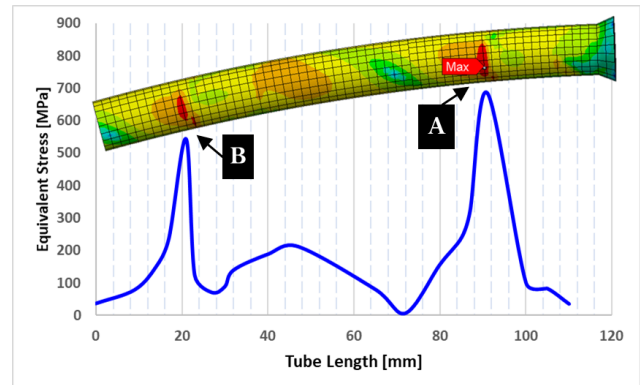
In the area of stress concentration, despite the presence of holes, microcracks are created under the effect of gas pressure fluctuations, and these microcracks gradually grow. It can be concluded from Fig. 7 that the tube failure occurs first at location A and then at location B from the end of the blade. The reason why the stress value is higher at the ends of the tube is that the end blade is more deformed than other blades under the effect of centrifugal force and gas pressure.

**Fig. 7.** Equivalent Von-Mises stress curves due to the static loads at the tube section vs. the tube length.

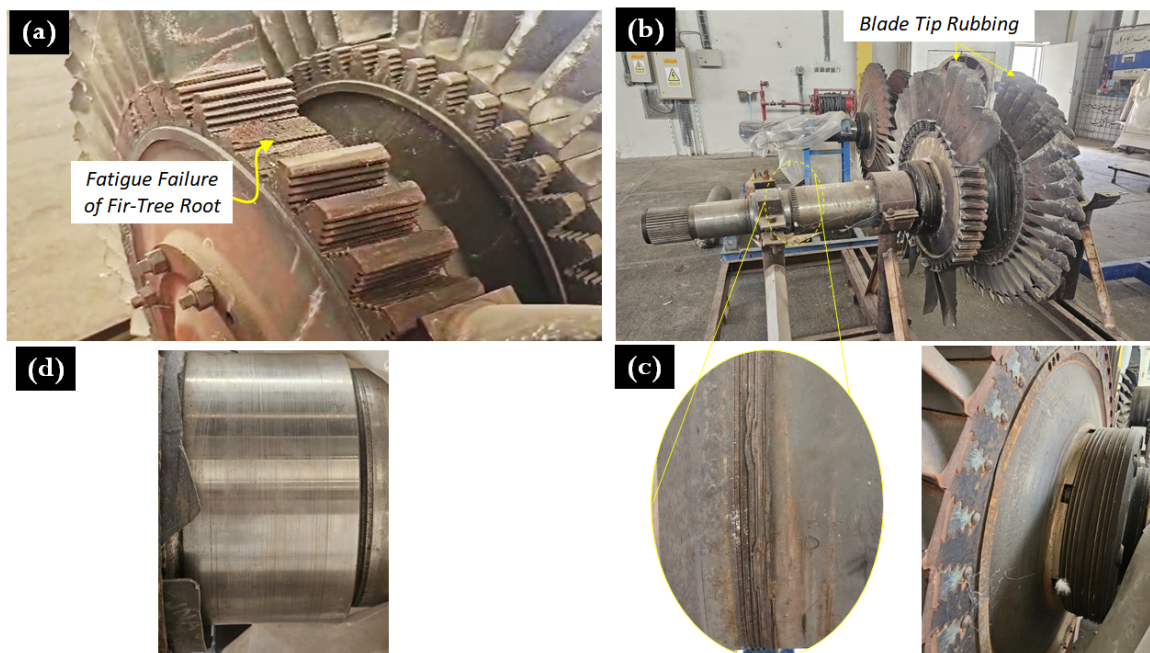
Fig. 8 shows the subsequent damage observed on the power turbine rotor assembly after the interconnection tube failure. As shown in Fig. 8a, fatigue fracture occurred at the fir-tree root of the first-stage disk due to increased stress concentration and vibration amplitude following the disconnection of the inter-blade tube. Fig. 8b presents severe blade tip rubbing against the casing, resulting from excessive radial displacement and unbalanced vibration. In Fig. 8c, contact marks and wear are visible on the labyrinth seals on the shaft, indicating axial and radial misalignment during operation. Finally, Fig. 8d shows metal-to-metal contact at the journal bearing seating area caused by shaft vibration and loss of oil film integrity. These cumulative damages confirm the propagation of stress concentration effects throughout the rotor assembly after the interconnection tube failure.

**Fig. 8.** Visual evidence of secondary damage after interconnection tube failure.

Fig. 8a illustrates the actual fatigue failure observed in the fir-tree root of the first-stage gas turbine rotor. The fracture occurred precisely at the contact region between the blade root and the disk, where cyclic loading and fretting stresses are concentrated. The visual evidence of material separation and surface oxidation indicates a long-term fatigue propagation rather than an instantaneous overload failure. The observed crack location in the failed fir-tree groove shows strong agreement with the stress concentration zone predicted in the finite element simulation (Fig. 9), confirming that the numerically identified high-stress region corresponds to the real fracture site on the disk. This correlation validates the accuracy of the FEM model and emphasizes the dominant role of stress concentration in initiating fatigue failure at the fir-tree root under combined mechanical and vibratory loading conditions.

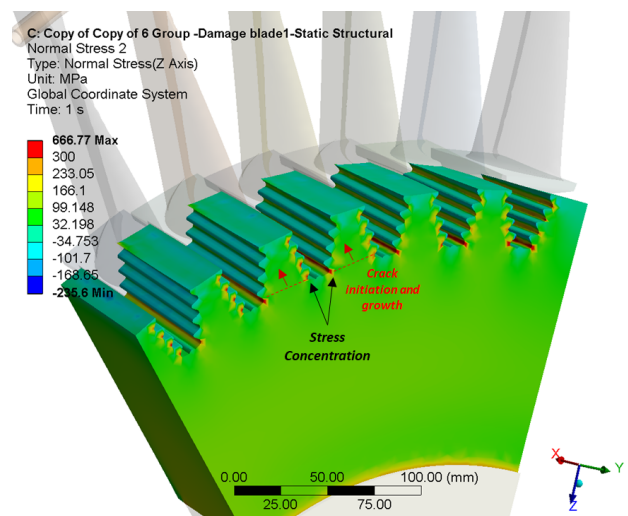
**Fig. 9.** Stress concentration on the turbine disk.
