# Stress Concentration and Fatigue Crack Propagation at the Fir-Tree Root of Gas Turbine Disks Caused by Interconnection Tube Failure between Blades

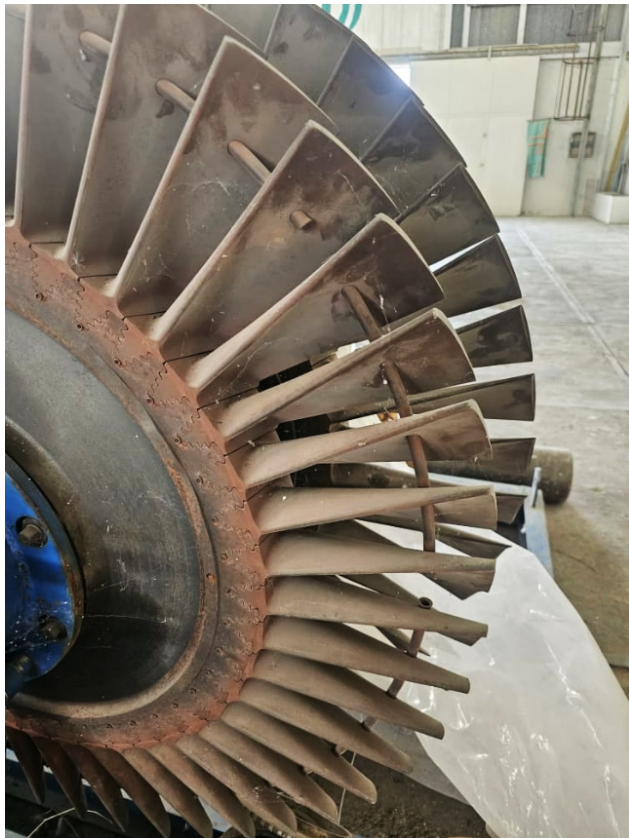
Fig. 2 presents the general assembly of the power turbine considered in this study. The power turbine consists of two stages, each comprising 42 blades. The first-stage blades are interconnected via an interconnection tube and arranged into six groups of six blades and two groups of five blades. The blade roots are of fir-tree type, designed to accommodate the high centrifugal and thermal loads encountered during operation.

**Fig. 2.** View of an undamaged power turbine.
